# Manhole Inspection Summary

Manhole # S43E\_\_017MH

Insp Date: **6/9/08 11:21 AM**

**Location** Address: **1520 e fairmount ave**

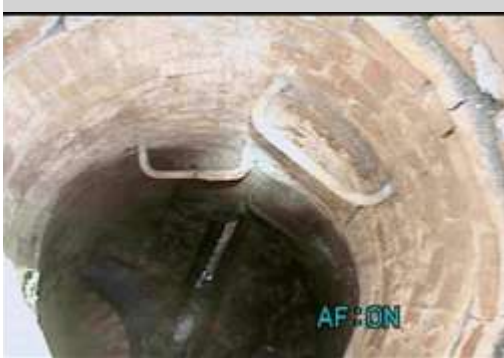
Defect 2

Count: **4** Missing: **0** ☒ Corroded

corroded steps

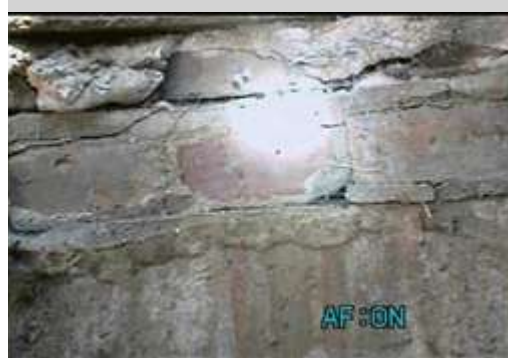
Defect 1

Condition: ☐ Sound ☐ Cracked ☐ Root Intrusion ☒ Loose Brick ☒ Deteriorated

Chimney deteriorated, loose bricks, frame adjustment

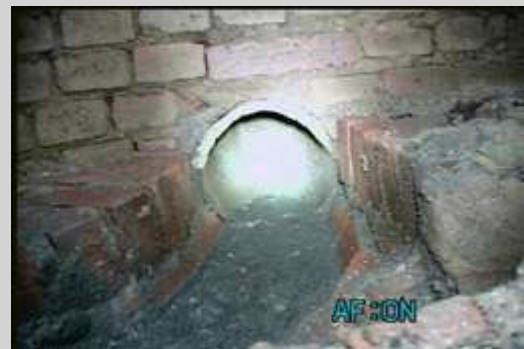
Drop In @ 3 O'Clock

Drop Condition: Partly Clogged
